Running Belt Repair

Running Belt Repair of a short conveyor in Dampier, WA.

INDUSTRY	Iron Ore Mining
CLIENT	A Top 3 Global Mining Company
APPLICATOR	Tiad Industries / Polyurea WA
PROJECT	Application of the BeltShield® system to repair a gouge in the belt from the skirts dropping onto it.
LOCATION	Pilbara, WA, Australia
SYSTEM	Surface prep, ShieldPrime SP, ShieldPoly CV to 3mm minimum.
DATE	March 2021

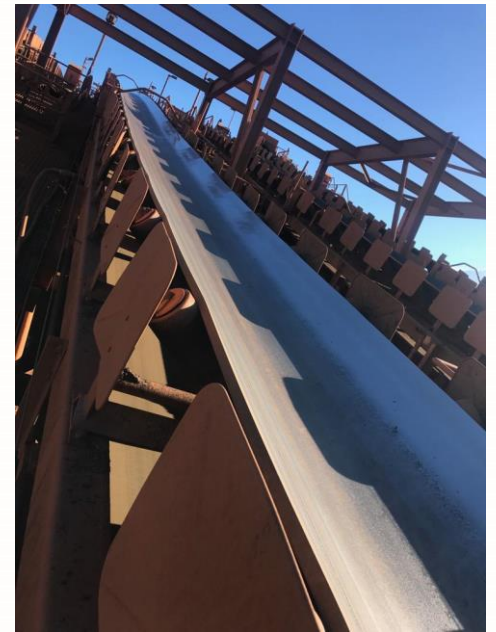
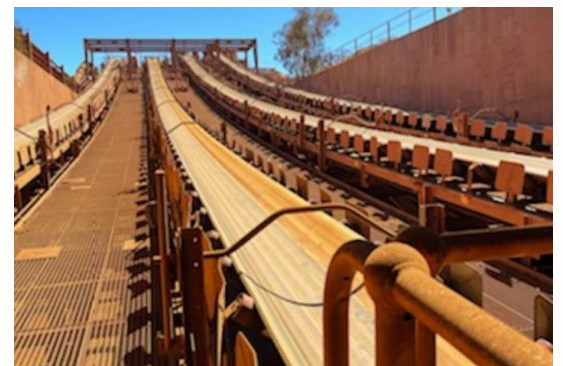
The owner wanted to repair the gouge left in the belt after one of the chutes dropped onto it.

Because of the length of this belt and the tack free time of the primer they were using, this belt was a stop-start application where they sprayed the primer and first pass of polyurea in sections as it was running, stopped before the top roller, waited a few minutes until the primer had cured sufficiently, then did the next section. It was done in 3 stops. The belt was then run continuously once the last primer was dry and the polyurea thickness was built to the required levels.

This belt was still operational and the polyurea in tact 12months+ after application.
